Your Inspection Report

Friday, November 20, 2020

Warren Commercial Inspections
171 Main Street, Suite B101
Ashland, MA 01721

Purpose of the report: • Property Condition Assessment

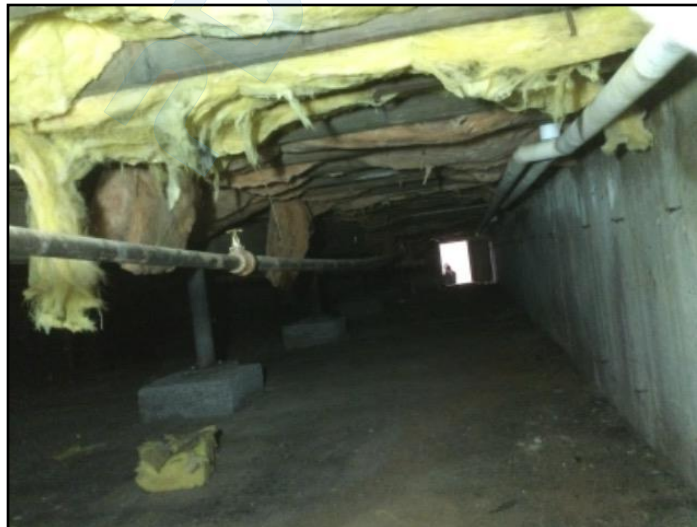
Unsupported sprinkler pipe due to wood damage is seen in the crawlspace. New supports are needed.

Task: Improve

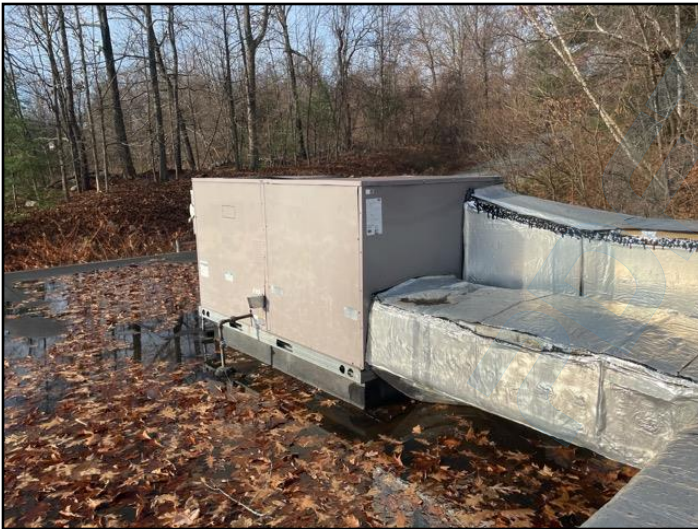
Condition: • Significant deficiencies noted

Pooling is noted

Task: Repair or replace

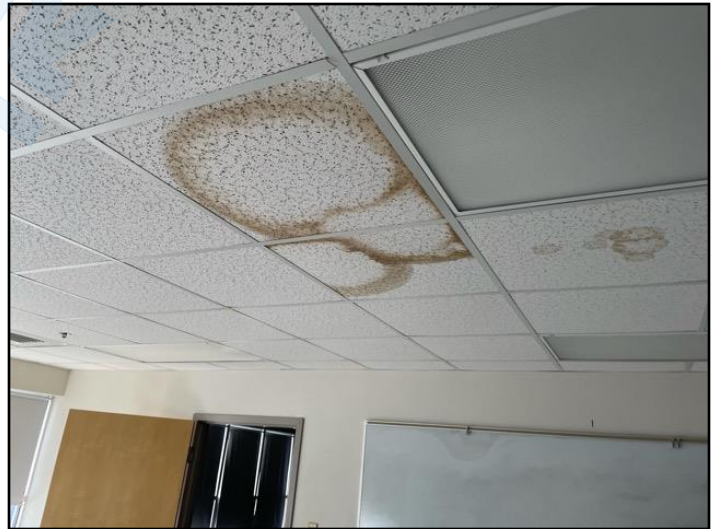
Numerous signs of leaks

Condition: • Poor

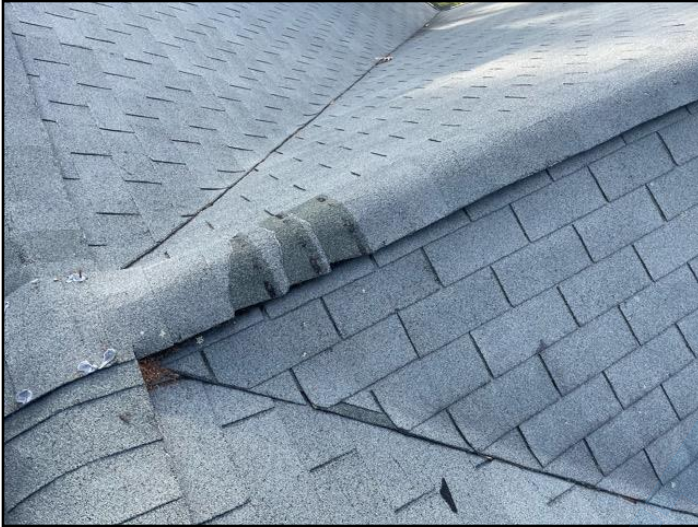
Approaching end of typical life expectancy

Task: Replace

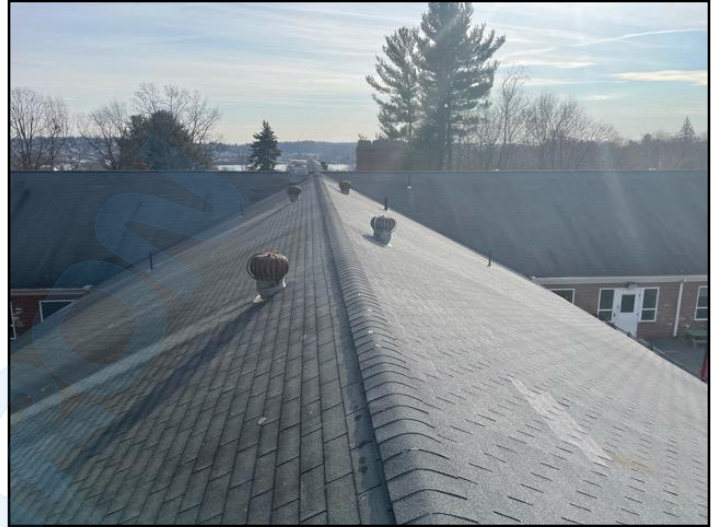
Approaching end of typical life expectancy

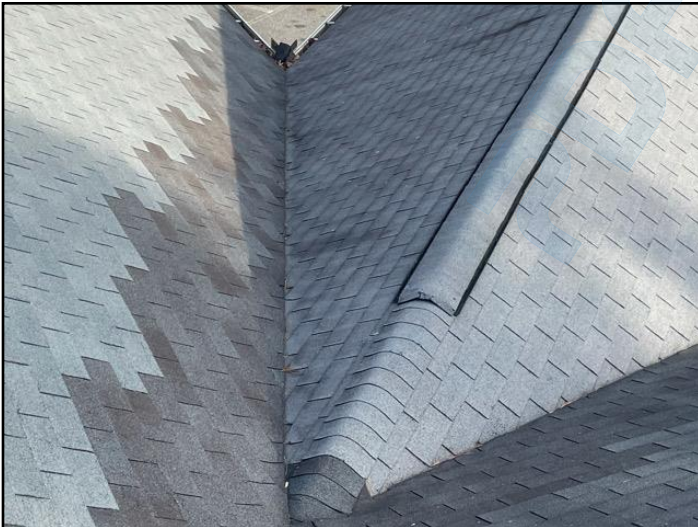
Repairs noted

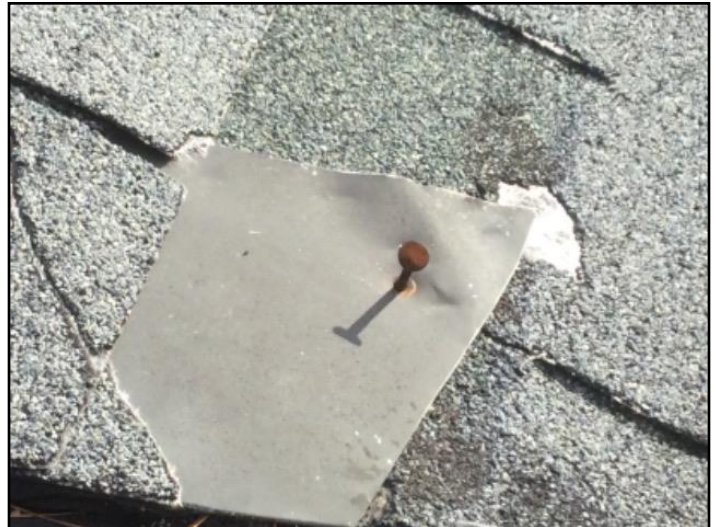
Condition: • Damaged sheathing

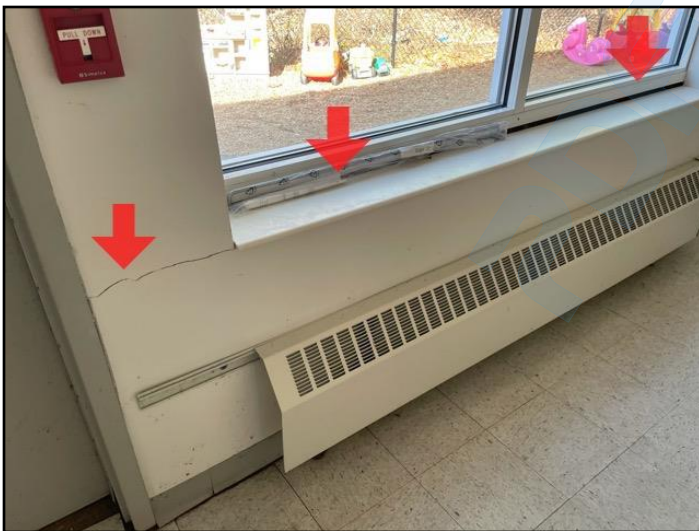
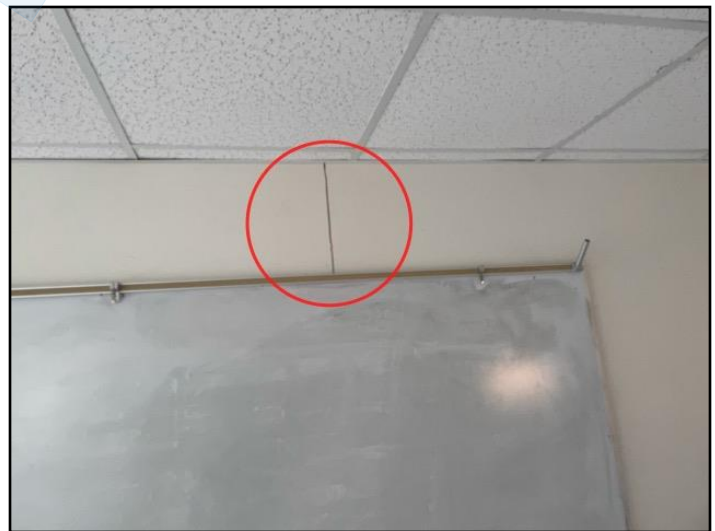
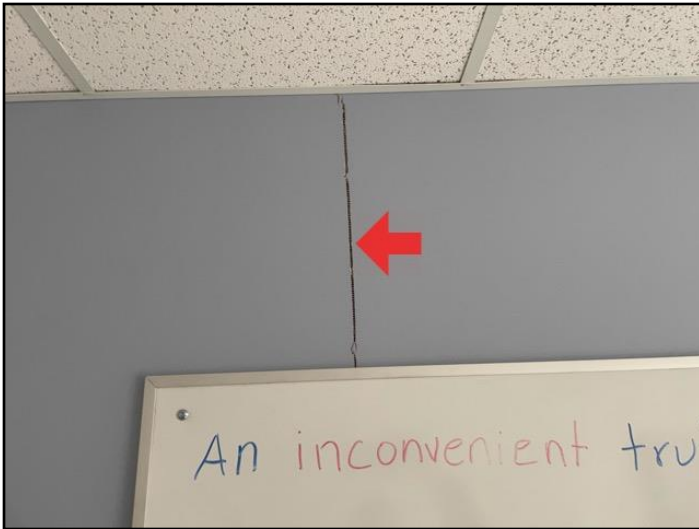
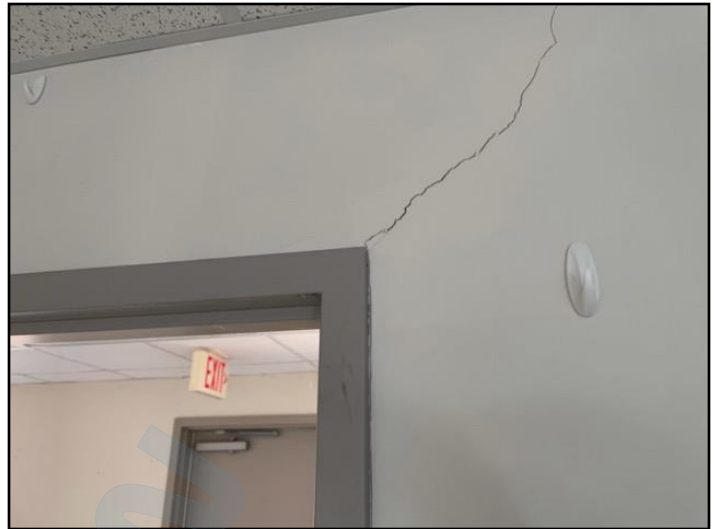
Condition: • Some walls and ceilings show cracks and bulges
Wall cracking and sagging due to noted structural failure are seen.

Task: Repair Further evaluation

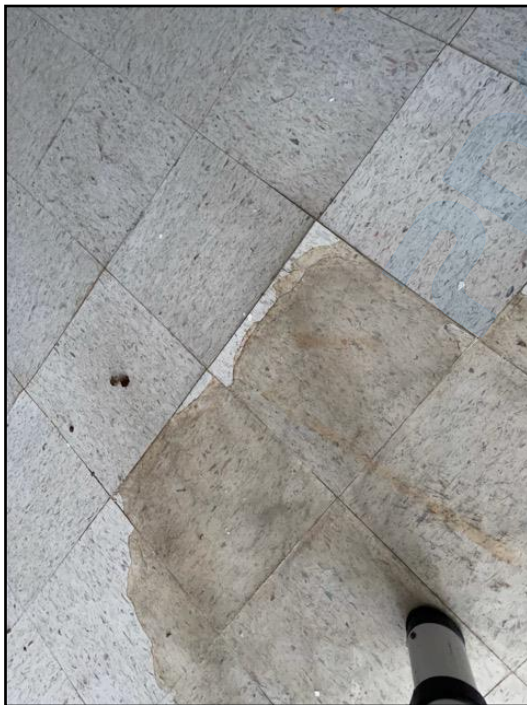
Moderate deficiencies noted

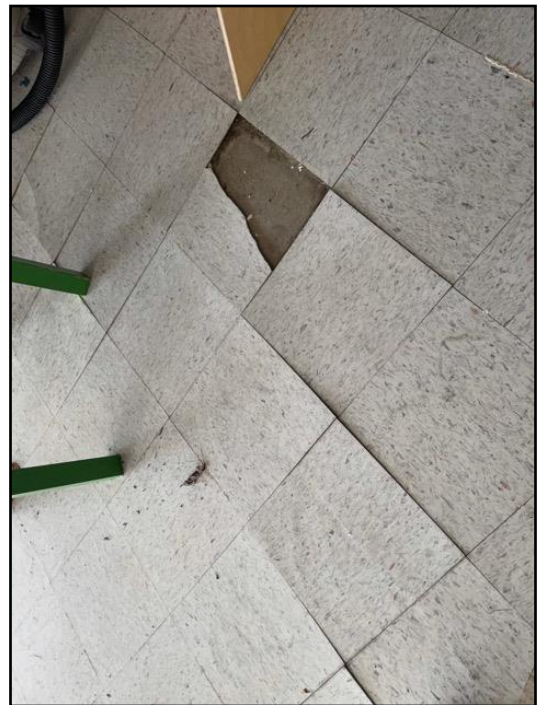
Condition: • Water damaged

Water damaged

Task: Repair

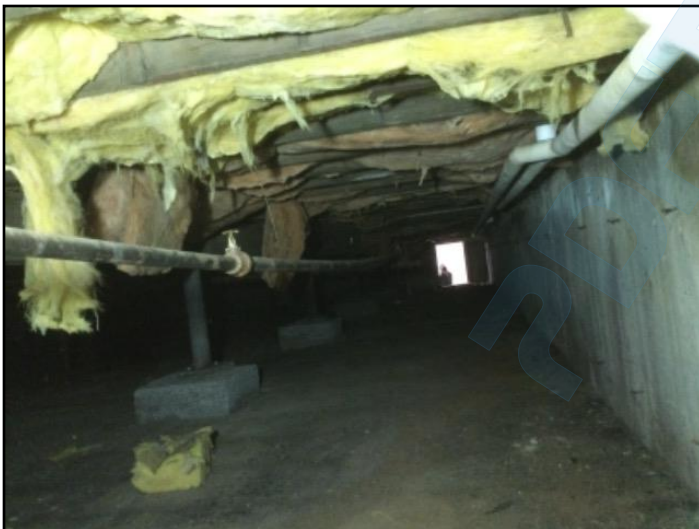
Fallen insulation in the floor structure

Task: Repair

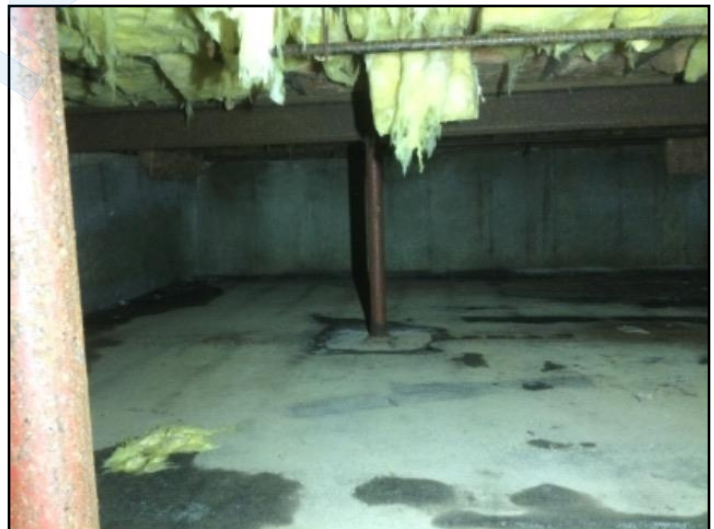
Fallen insulation in the floor structure

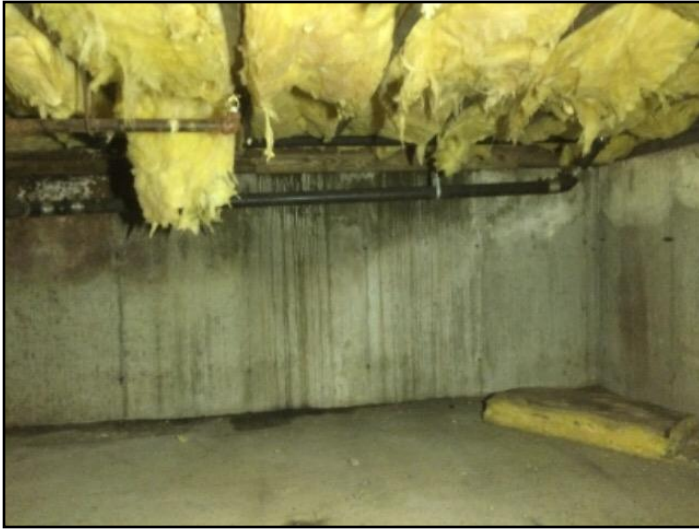
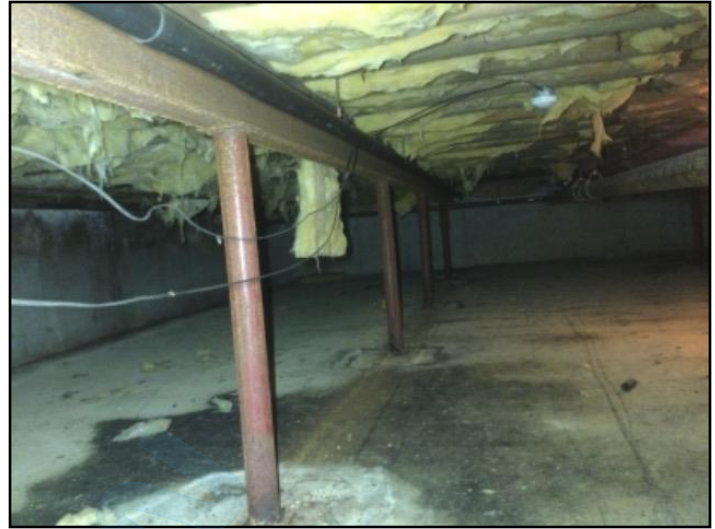
Fallen insulation in the floor structure

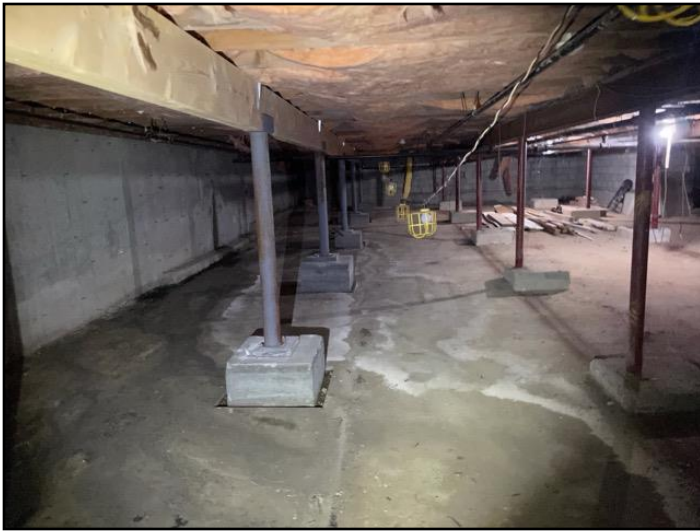
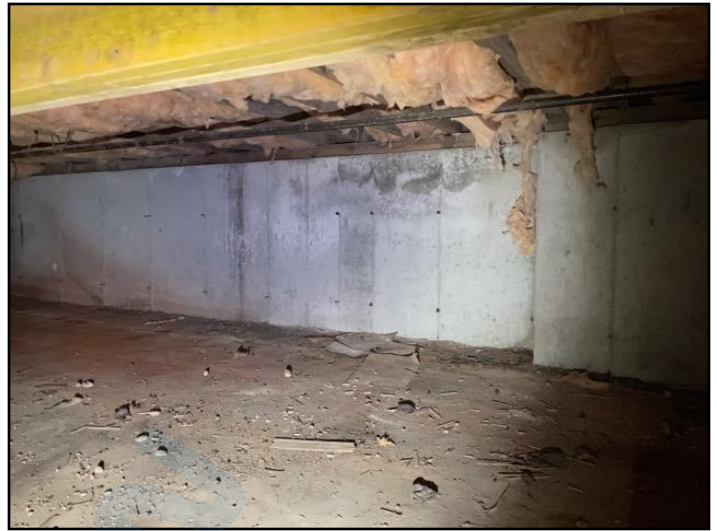
Settlement cracks and water penetration are seen throughout the crawlspace and basement

Settlement cracks noted

Task: Repair/seal

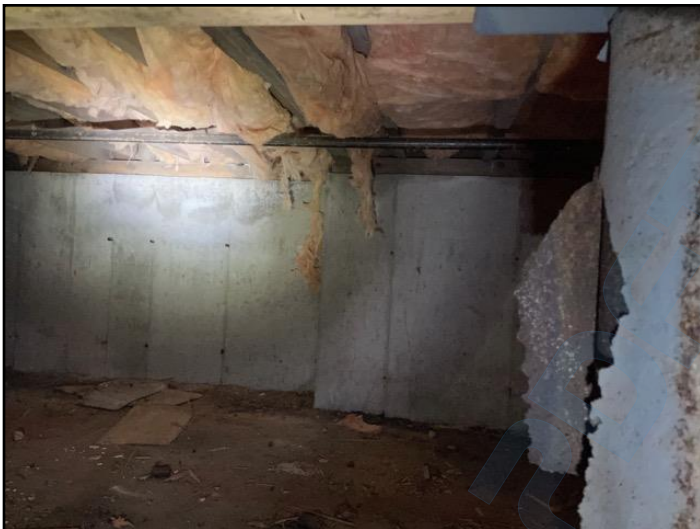
Settlement cracks noted

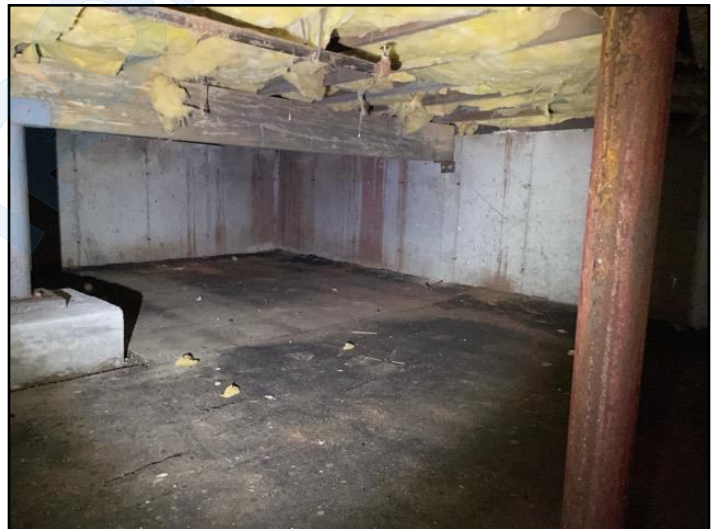
Settlement cracks noted

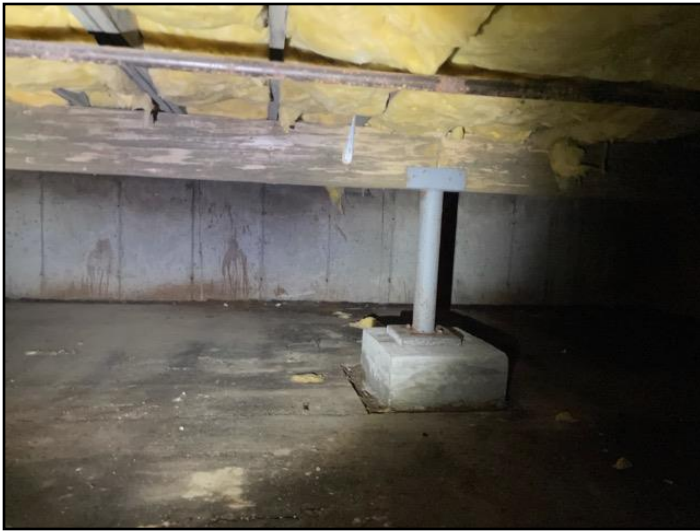
Settlement cracks noted

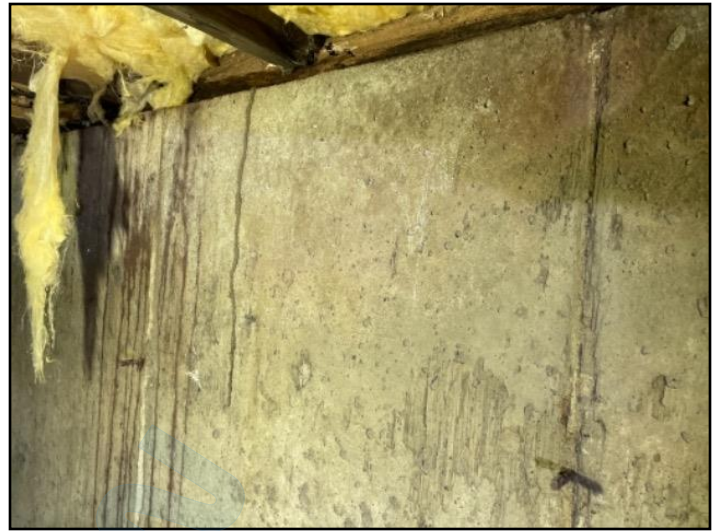
Settlement cracks noted

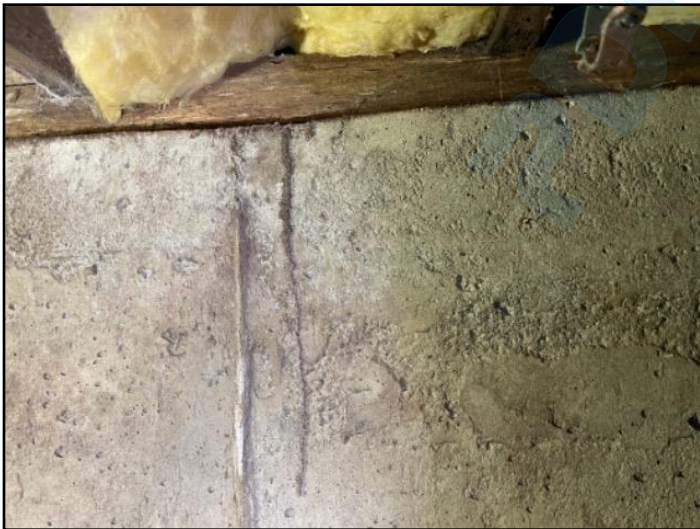
Rear sill of the building has widespread termite and moisture damage. Significant structural damage is seen. Interior structure above has settled. Widespread damage is seen.

Termite shelter tubes

Task: Repair or replace

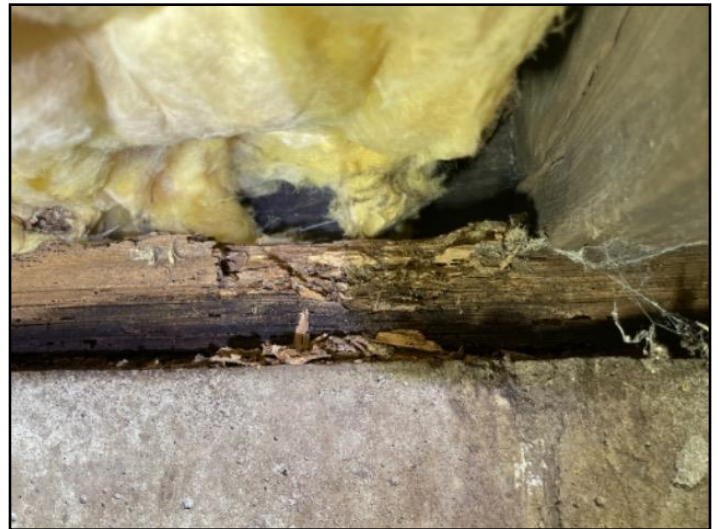
Evidence of insect damage noted

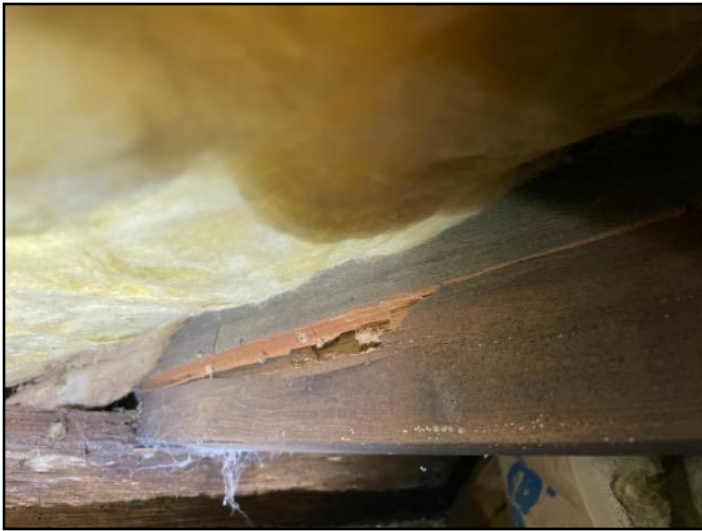
Evidence of insect damage noted

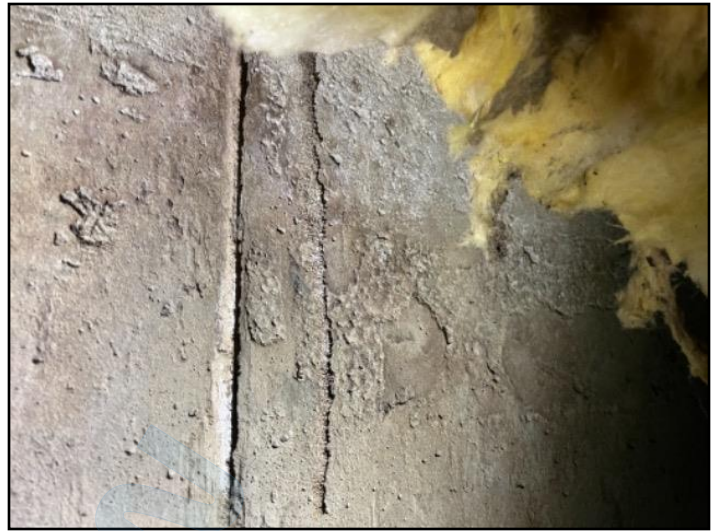
Termite shelter tubes

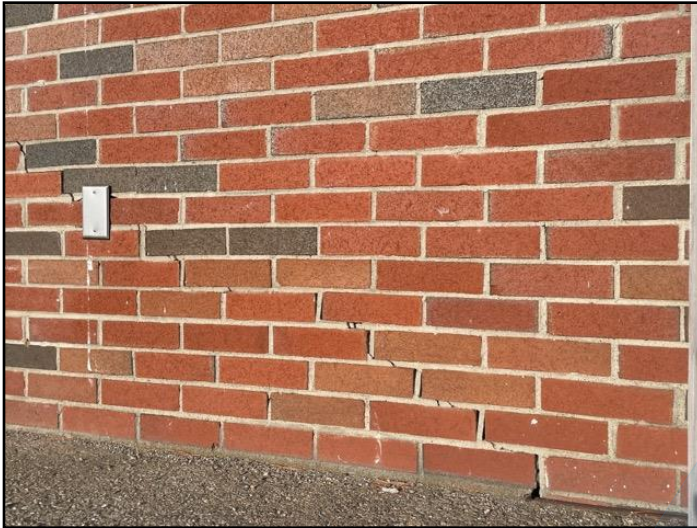
Brick displacement seen at left front wall

Damage

Task: further evaluation is needed

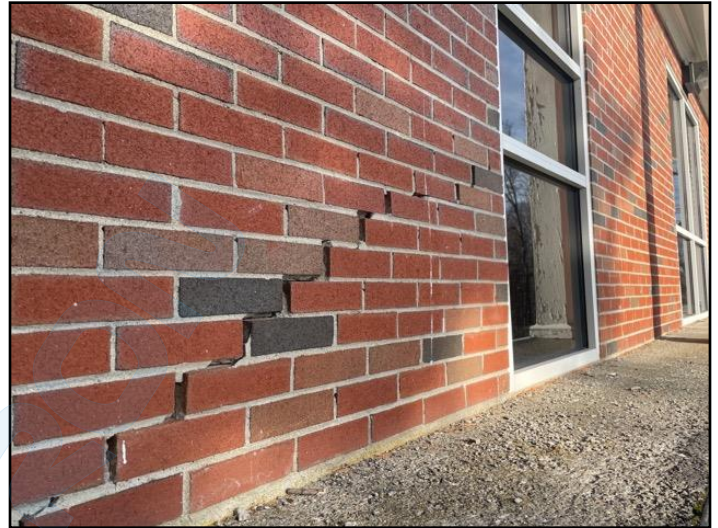
Damage

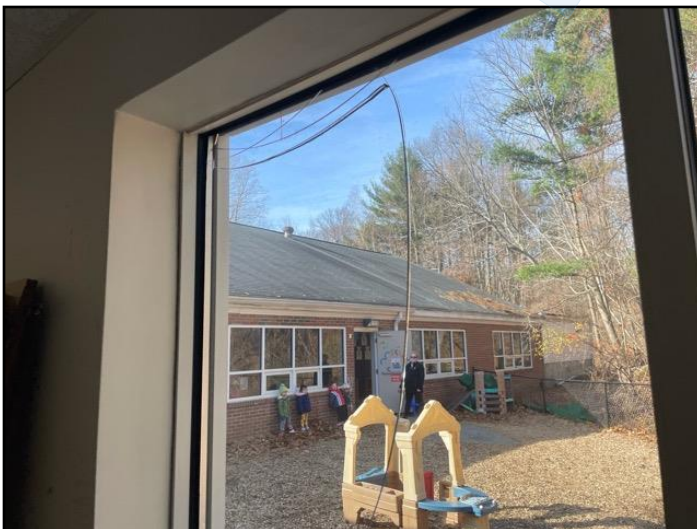
Broken glass is noted due to the stress of structural failure.

Broken glass

Task: Repair

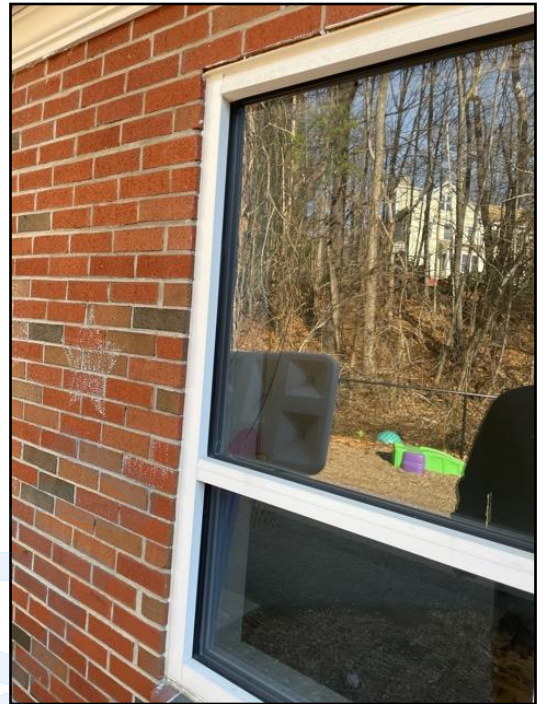
Broken glass

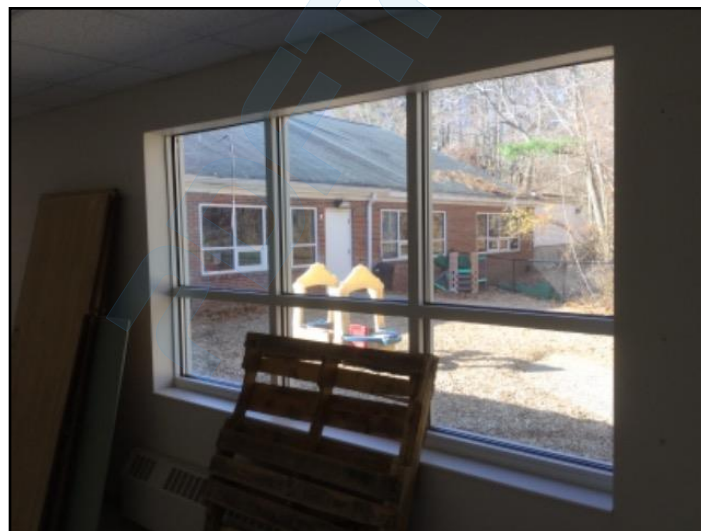
Broken glass

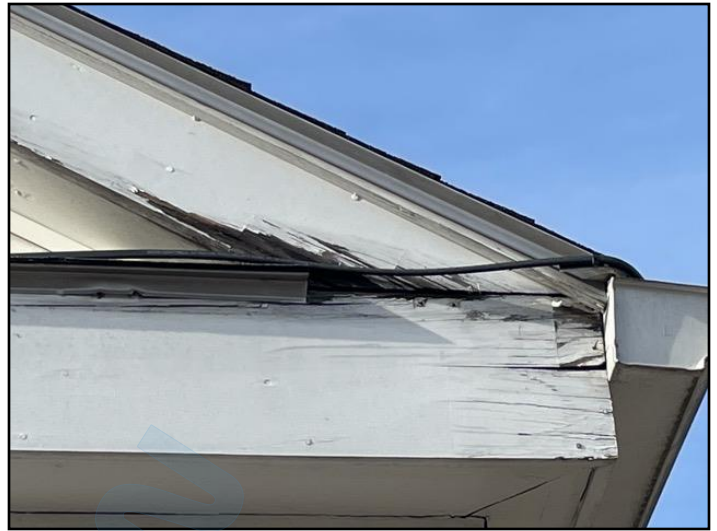
Widespread water damage seen throughout the fascias, soffits and rake boards. Removal/replace

Rotted

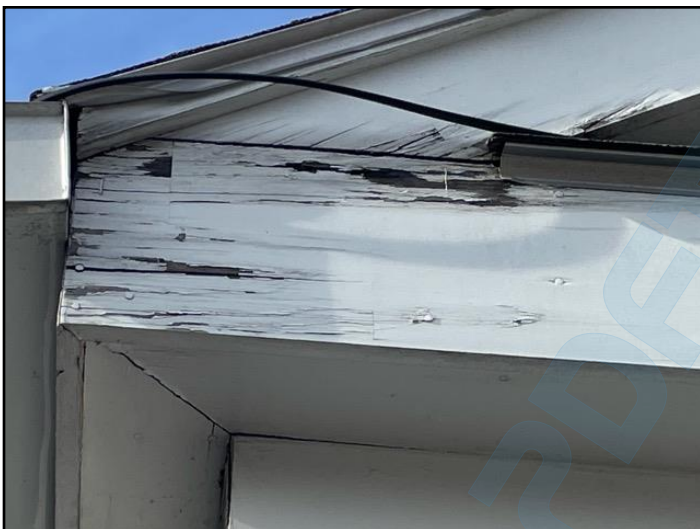
Rotted

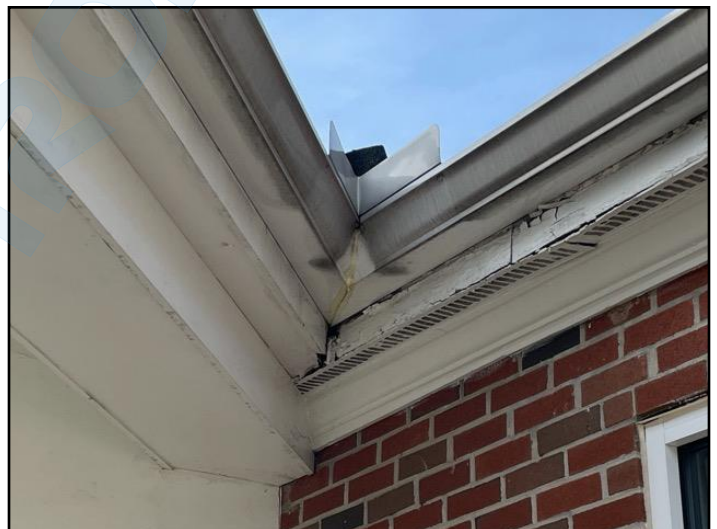
Rotted

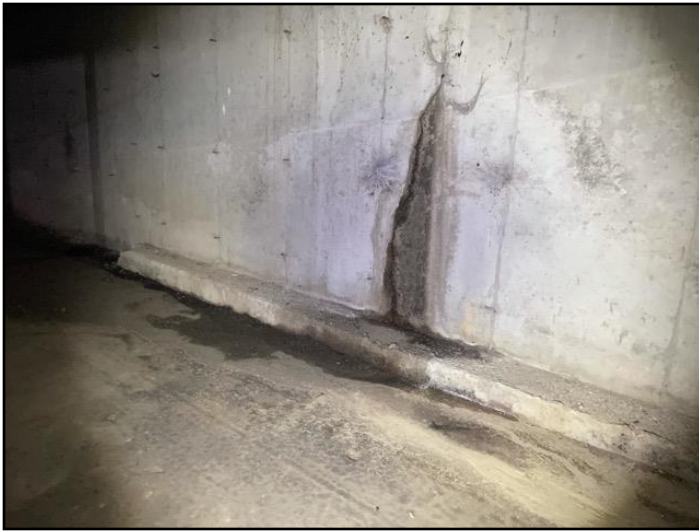
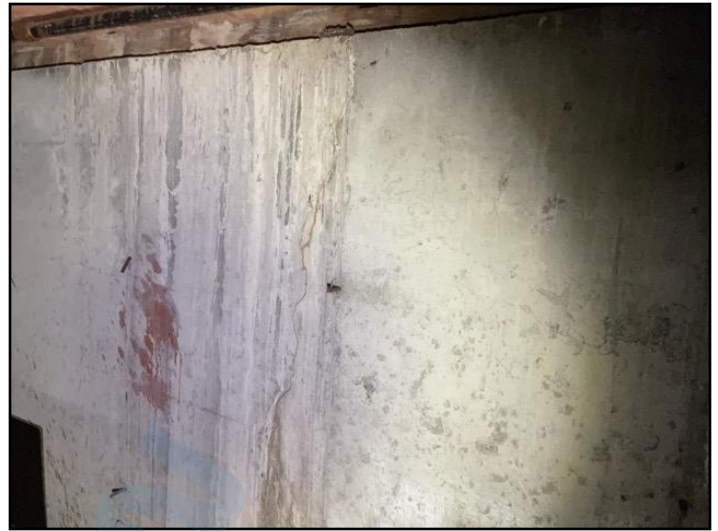
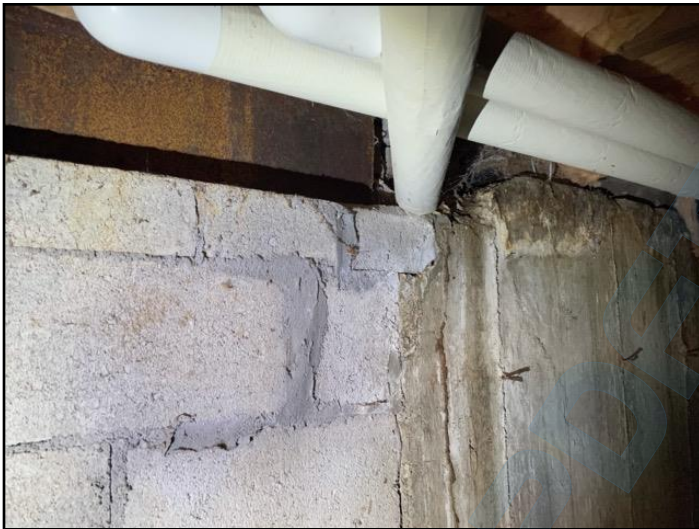
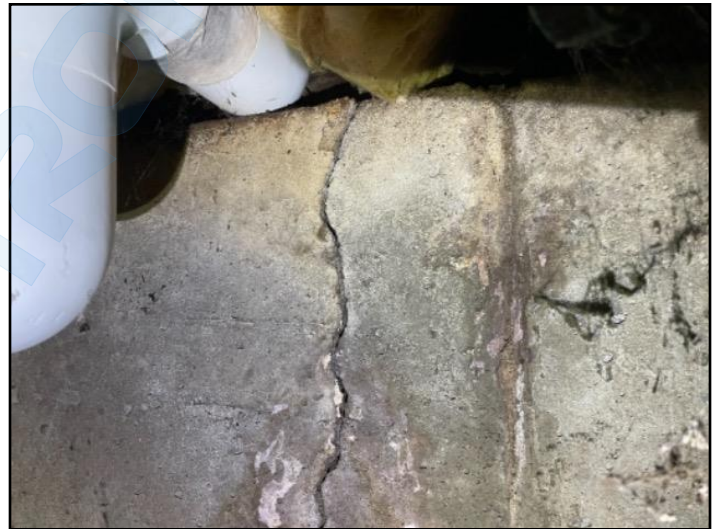
Poor drainage at asphalt sidewalk at rear right wing has contributed to major structural damage. Poor grading and drainage is contributing to foundation leaks seen in basement and crawlspaces.
